**Flood Control Project Maintenance  
Levee Inspections**  
**LMA District Cover Sheet**  
**Spring 2019 Levee Inspection Results**

**Reclamation District No. 0003 Grand Island**

**Spring 2019 Levee Inspection Results**

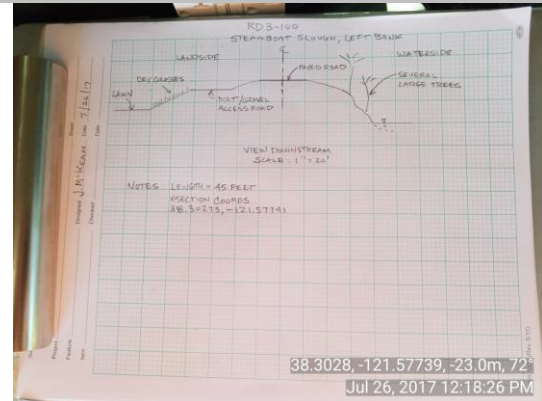
Photo 3 of 3 : LEVAL\_SP\_2019\_274\_2395.jpg

LM Start	0.18	Rating **	A/W	Issue No.	52 (cont)	
LM End	0.21	Issue Type +	Ma	Location *	WS	
Category	Supplemental			GPS Latitude/Longitude		
				Start		End
Item	2017 Storm Damage			38.302981 °		38.302778 °
				-121.577336 °		-121.577683 °
DWR ID	DWR_RD0003_01_s_2018_52					
Comment Code						
Inspector Comment						
Levee Evaluation Comments						
Description: District station 9+63 to 10+85, Sec. 07, T. 5 N. R. 4 E., M.D.M. An erosion site exists along approximately 122 linear feet of the waterside slope of Steamboat Slough (Unit 1). Erosion commences approximately 1/3 of the way down the slope from the crown to the waterside toe. Erosion is undercutting existing trees.						
Site ID No: 274						
Site Designation: LMA-100						
Repair Type: Erosion						
Rating: Serious						
Field Date: 7/26/2017						
Notes: trees undercut by erosion

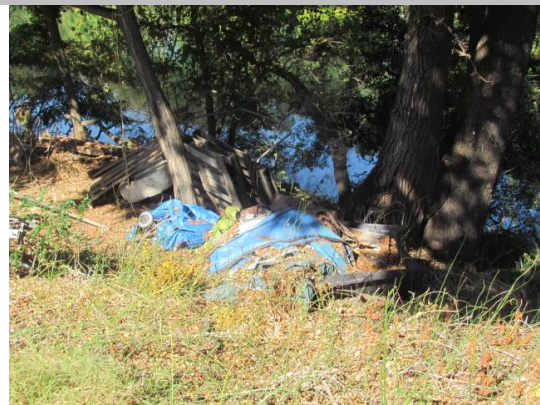
Photo 1 of 4 : SP\_2019\_RD0003\_24\_188\_20190311\_00093.jpg

LM Start	0.21	Rating **	M	Issue No.	188
LM End	0.21	Issue Type +	En	Location *	WS
Category	Earthen Levee			GPS Latitude/Longitude	
				Start	End
Item	Encroachments			38.302625 °	38.302625 °
				-121.577683 °	-121.577683 °
DWR ID	DWR_RD0003_01_s_2012_188				
Comment Code					
GA : Garbage					
Inspector Comment					
Landowner has piled wooden boards and trash on waterside berm.

Looking southwest at garbage on waterward berm. (Fall 2014)

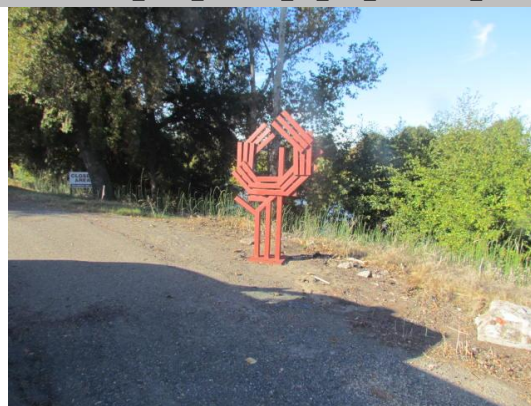
Photo 1 of 1 : SP\_2019\_RD0003\_24\_132\_20190311\_00092.jpg

Looking southwest at sign on waterward shoulder.

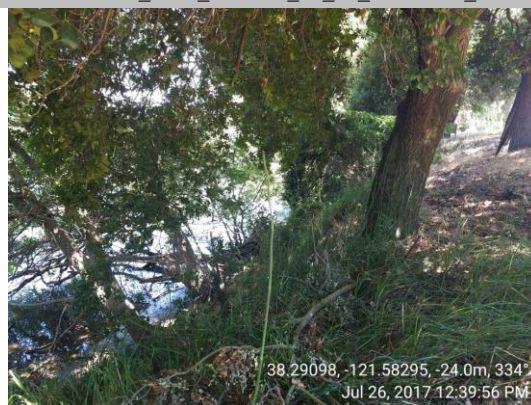
Photo 2 of 3 : SP\_2019\_RD0003\_24\_60\_20190311\_00047.jpg

LM Start	1.09	Rating **	A/W	Issue No.	60
LM End	1.10	Issue Type +	Ma	Location *	
Category	Supplemental			GPS Latitude/Longitude	
				Start	End
Item	2017 Storm Damage			38.290819 °	38.290706 °
				-121.582942 °	-121.582939 °
DWR ID	DWR_RD0003_01_f _ 2017_60				
Comment Code					
Inspector Comment					
Levee Evaluation Comments					
Description:District station 57+57 to 57+98, Sec. 18, 1. 5 N. R. 4 E., M.D.M. An erosion site exists along approximately 41 linear feet of the water side slope of Steamboat Slough (Unit 1). The erosion commences approximately 1/2 of the way down the slope from the crown to the waterside toe.					
Site ID No:276					
Site Designation:LMA-102					
Repair Type: Erosion					
Rating:Area of Concern					
Field Date:7/26/2017					
Notes:

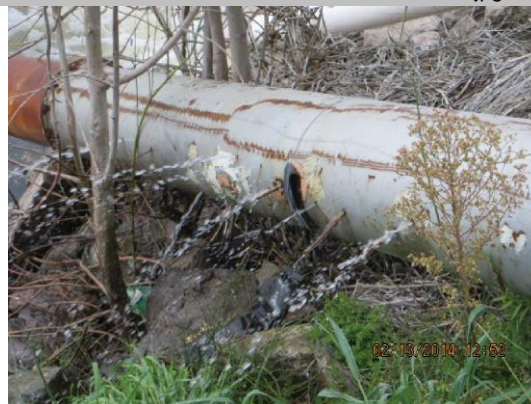
Photo 2 of 3 : UCIP\_SP\_2019\_29563\_54621.jpg

Multiple leaks in suction pipe on WS slope.

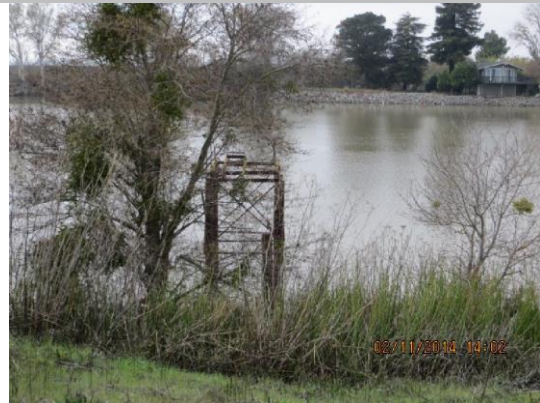
Photo 1 of 3 : UCIP\_SP\_2019\_29403\_54462.jpg

Steel pier on WS toe, pipe visible on ground directly in front of pier on slope.

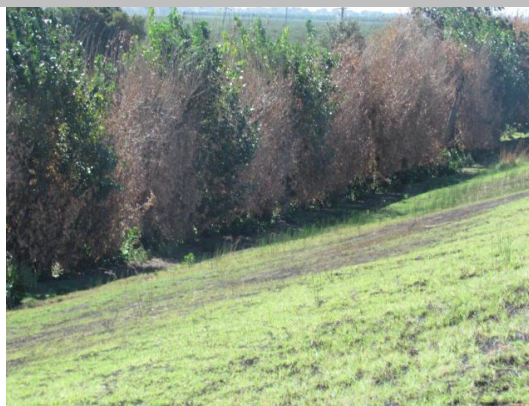
Photo 1 of 3 : SP\_2019\_RD0003\_24\_78\_20190311\_00069.jpg

Looking eastly at trees blocking view of landward toe. (Fall 2015)

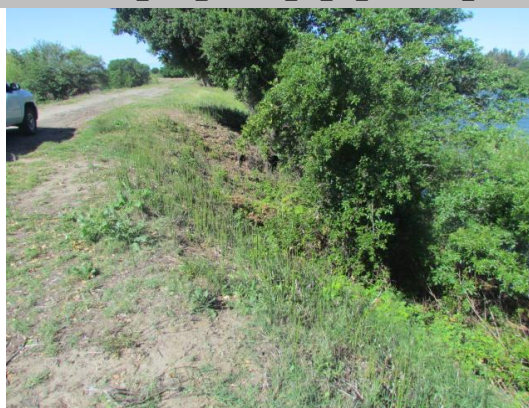
Photo 1 of 2 : SP\_2019\_RD0003\_24\_97\_20190311\_00084.jpg

Looking south at erosion on waterward slope.

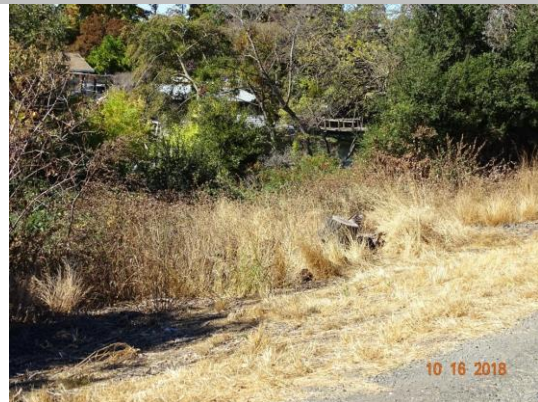
Photo 1 of 3 : SP\_2019\_RD0003\_25\_129\_20190311\_00091.jpg

View of tree limbs that have mostly been removed from waterside slope (October 2018).

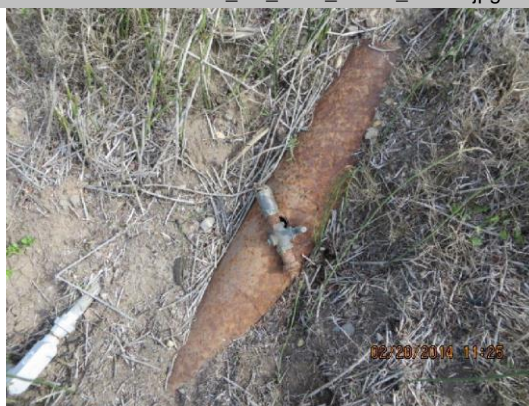
Photo 1 of 3 : UCIP\_SP\_2019\_30577\_56345.jpg

Siphon breaker/vent broken off pipe at LS slope.

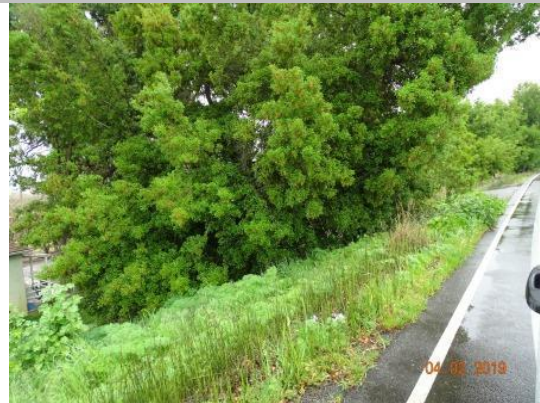
Photo 1 of 1 : SP\_2019\_RD0003\_25\_63\_20190404\_00320.jpg

View looking upstream at thick trees on the landside slope (Spring 2019).

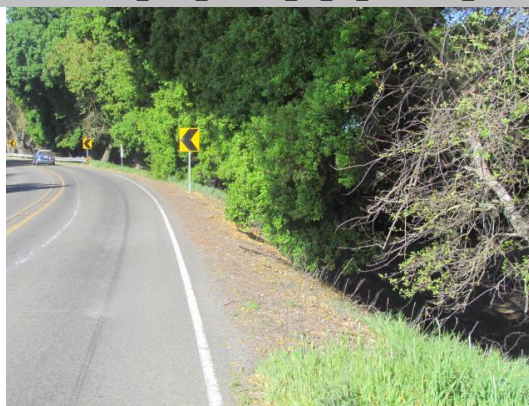
Photo 1 of 1 : SP\_2019\_RD0003\_25\_64\_20190311\_00042.jpg

Looking southwest at dense trees on landward shoulder and slope.

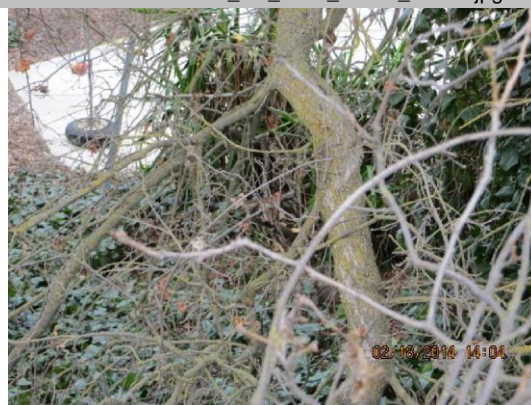
Photo 3 of 3 : UCIP\_SP\_2019\_30408\_55929.jpg

Concrete standpipe covered in vegetation on LS toe.

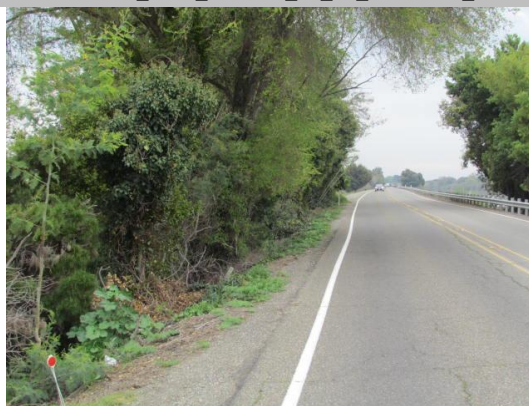
Photo 1 of 1 : SP\_2019\_RD0003\_25\_22\_20190311\_00023.jpg

Looking east at dense landscape on landward shoulder and slope.

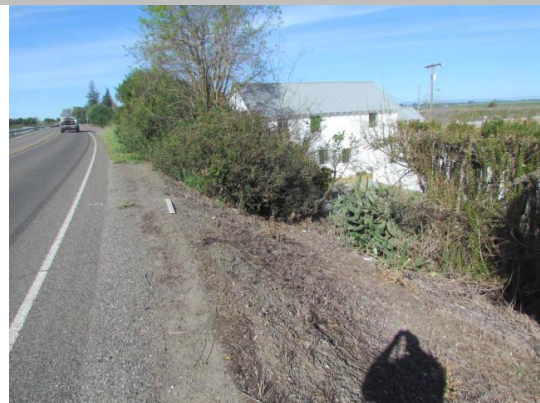
Photo 1 of 2 : SP\_2019\_RD0003\_25\_84\_20190311\_00064.jpg

Looking west at dense landscaping on landward slope and toe. (Spring 2015)

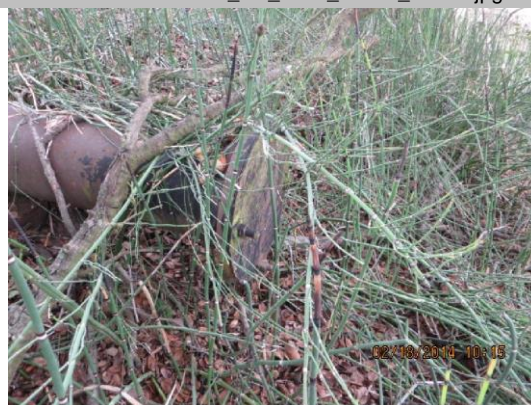
Photo 2 of 3 : UCIP\_SP\_2019\_40544\_55693.jpg

Steel plate bolted over pipe end on WS slope.

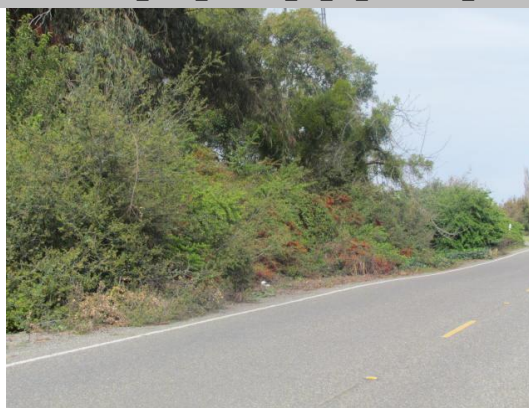
Photo 1 of 1 : SP\_2019\_RD0003\_25\_60\_20190311\_00041.jpg

Looking west at dense landscaping on landside shoulder and slope.

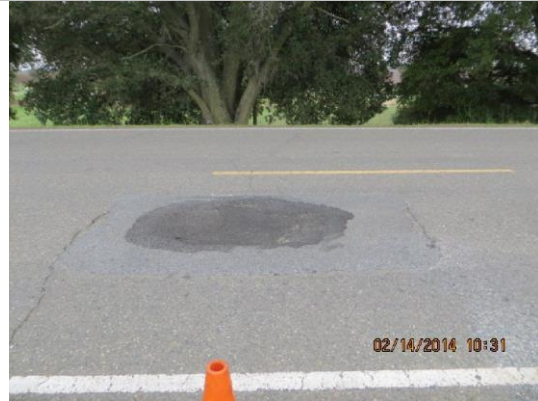
Photo 2 of 3 : UCIP\_SP\_2019\_53536\_55361.jpg

Apparent sinkhole over pipe at crown.

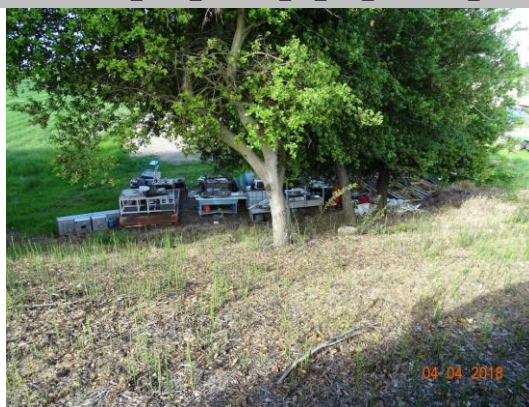
Photo 2 of 2 : SP\_2019\_RD0003\_25\_166\_20190311\_00142.jpg

Equipment at landside toe.
